IC-NOCMAT 2007 Maceió  
*International Conference on Non-Conventional Materials and Technologies:  
Ecological Materials and Technologies for Sustainable Building  
Maceió, Alagoas, Brazil, 14<sup>th</sup>-17<sup>th</sup> October 2007  
In Honour of Professor R.N.Swamy*

**PERFORMANCE OF SILICA FUME MORTAR UNDER  
MARINE ENVIRONMENT.**

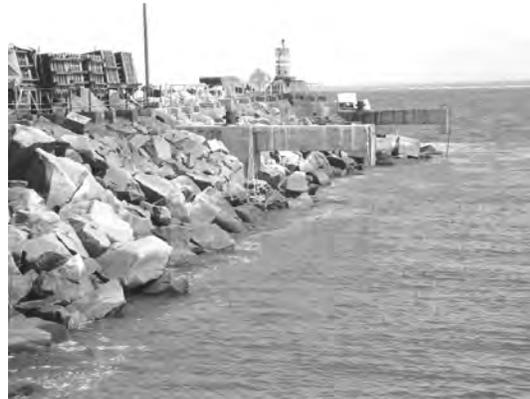
Since the objective is evaluate the influence of the silica fume on mortars, two mixtures were proposed – one containing the said chemical admixture and another without it, as shown in table 01. Both of them were exposed to the exact same environment simultaneously, which happened to be the breakwater that protects the docks of a chemical company (Fig. 01).

**FIGURE 01 - MARINE BREAKWATER.**

Although the chemicals manipulated in such industry could compromise the results, the docks where the experiments took place are pretty far from the company facilities, allowing one to neglect the effects the factory's chemical compounds could have over the mixtures. Also, the seawater quality is monitored by a third-party company, which stated that the water conditions are on par with other samples taken several kilometers away from the docks.

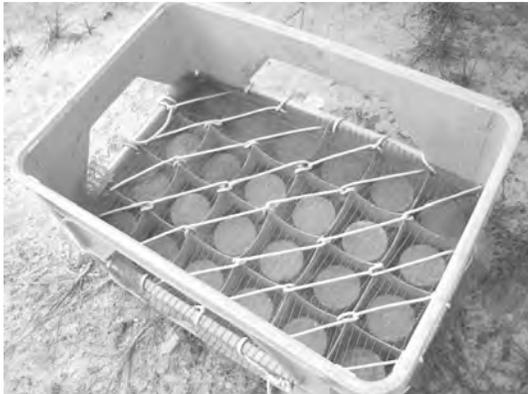
Both type of mortars were cast in 10 cm x 5 cm cylindrical molds, following the guidance of NBR 5738:1994 [11] and stood there for 24 hours, when they were demolded and accommodated inside a plastic box primarily used to carry soft drinks. The top of the box was covered and sewed with a plastic net (Fig. 02) and it was taken to the selected breakwater to start the exposition period.

**FIGURE 02 - MORTAR CYLINDERS.**

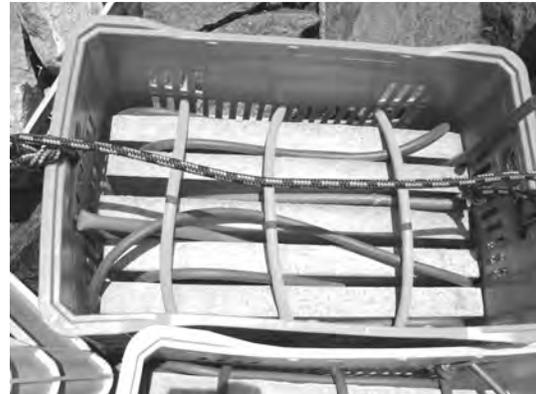
**FIGURE 03 - MORTAR PLATES.**

The mortar was also cast inside 50 cm x 15 cm x 4 cm rectangular molds to shape the armed plates. The steel was a mesh with 5 cm x 5 cm openings and one salient bar covered with rubber tape to, latter, permit the execution of the corrosion potential tests. Five specimens at a time were placed inside another plastic box and a hose was used to help separate the plates, avoiding contact damages (Fig. 03).

All the specimens were placed and tied together in the tide variation area of the breakwater where they constantly experienced wetting and drying cycles. This procedure lasted for 14, 28, 91, 135 and 180 days. In the end of each time period, a group of 18 mortar cylinders (9 based in mix #1 and 9 made with mix #2) and 6 mortar plates (3 from mix #1 and 3 made with mix #2) were taken to perform compressive, tensile and elastic modulus tests, as well as measure the corrosion potential of the plates and observe possible changes in the hydrated cement phases with the aid of X-ray diffraction.

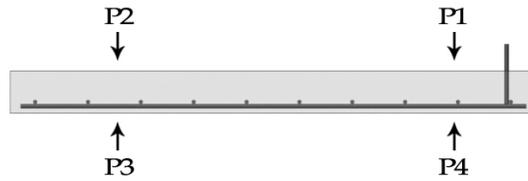
The corrosion potential tests were executed following the orientation of the ASTM C 876-91 norm. The mortar plates were taken to the laboratory and the tests were performed using a digital multimeter model MD 6200 from ICEL and copper-copper sulfate electrodes. There were four points of measurement (named P1, P2, P3 and P4) per specimen, shown at Fig. 04, and the results are presented at Table 06.

**FIGURE 05 - POINTS OF MEASUREMENTS FOR THE CORROSION POTENTIAL TESTS.**

Although the ASTM C 876-91 says that beyond  $-350$  mv there's more than 90% probability that the reinforced steel, no mortar specimen showed signs of corrosion after they were opened. All the steel inside them was in perfect conditions, with very small, if any, orangish stains. Maybe these are proof that corrosion was starting to develop, particularly in the case of silica-free mortars, but the mortars with silica also exhibited little stains on their steel armor. Nevertheless, more research should be done to better understand the influence of silica on the corrosion phenomenon.

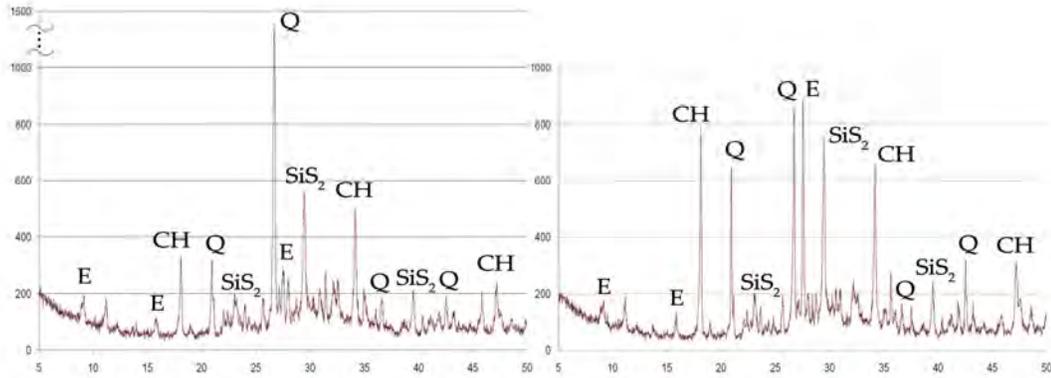
Some of the X-ray diffraction results are shown in Fig. 06 and 07. The samples for this experiment were taken from the tensile strength specimens, and two kinds of sampling were made – one was composed from the mortar in the outer surface of the ruptured cylinders (around 1 cm deep) and the other was obtained from the inner part of the same cylinders (about 1 to 2.5 cm deep). The complete graphics can be found at ALMEIDA [19].

The figures show some variations within the compounds of the hydrated cement paste. At first, it's worth noting that the  $\text{Ca}(\text{OH})_2$  levels are significant lower in the silica fume mortars at the 28<sup>th</sup> day, when compared to the mortars made from mix #2 at the same age. This can be explained as the result of the pozzolanic reaction of the silica fume – which consumes the calcium hydroxide present in the ionic pore solution of the cement paste.

Other phases that exhibited variations were the ettringite and silicon sulfide ones. If it's made a comparison between the mortar types, these compounds showed fairly higher levels in the specimens taken from the surface of the cement only mortar than the ones obtained from the silica fume.

**FIGURE 06 - X-RAY DIFFRACTION OF 28 DAYS OLD SURFACE SAMPLES FROM SILICA FUME (RIGHT) AND CEMENT ONLY (LEFT) MORTARS.**  
 Q = Quartz; CH = Calcium Hydroxide; E = Ettringite; SiS<sub>2</sub> = Silicon Sulfide.

The X-ray diffraction helped see some phase changes that took place in the mortars. It showed that the silica fume mortar  $\text{Ca}(\text{OH})_2$  levels vary greatly, and the lowest values for this phase were observed in the samples after almost 180 days of exposure. This wasn't true for the cement only mortars – they managed to keep their calcium hydroxide above 500 A.U. (aleatory units).

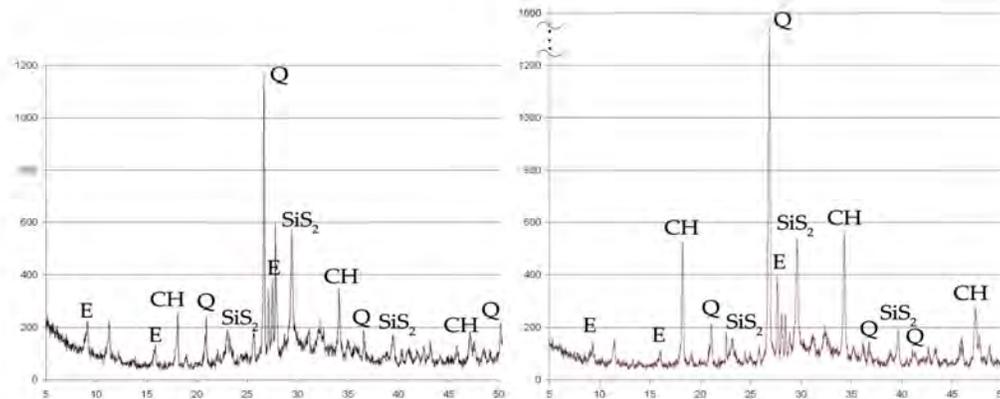
In the 180<sup>th</sup> day, the test reveals some changes in the X-ray peaks. Regarding the mix #2 mortar, it can be noted that, while the Ca(OH)<sub>2</sub> higher values may have come down a little, they're still greater than the ones seen in the 180 days old silica fume mortar. This difference is even more pronounced if the specimens from inside the mortars are contemplated. Alternatively, the ettringite and silicon sulfide values remain almost the same for both mortar types.

**FIGURE 07 - X-RAY DIFFRACTION OF 180 DAYS OLD SURFACE SAMPLES FROM SILICA FUME (RIGHT) AND CEMENT ONLY (LEFT) MORTARS.**  
 Q = Quartz; CH = Calcium Hydroxide; E = Ettringite; SiS<sub>2</sub> = Silicon Sulfide.
