THE USE OF EARTH AS A RECONSTRUCTION MATERIAL: A CASE STUDY IN ITALY.

Chiara Calderini¹, Sara Frumento², Sergio Lagomarsino³

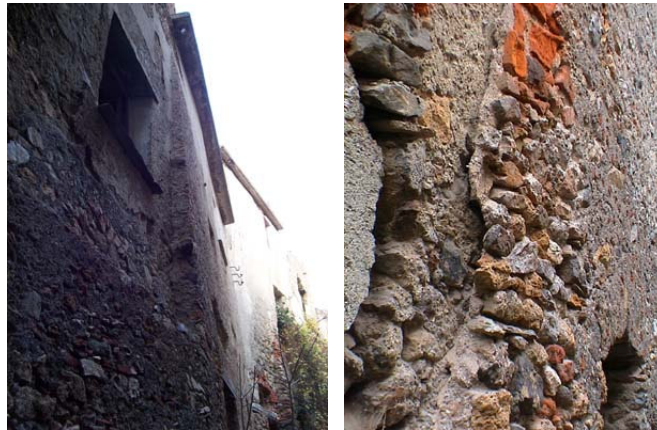
Figure 2: Spurs (on the left) and wall thickenings (on the right).

The long-time static precariousness of the village is exemplified not only by a number of ancient written documents which report the collapse risk of buildings, but also by the existence of ancient retrofitting interventions, such as spurs (Figure 2, on the left) and wall thickenings (Figure 2, on the right). Such precariousness depends on different causes.

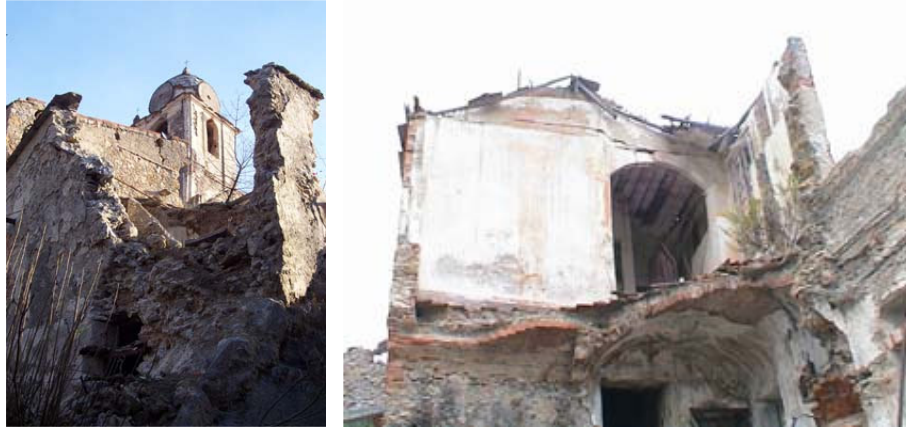
Figure 3: Masonry shattering (on the left) and internal collapses with vegetation growth (on the right).

The degradation of the walls has also been also favoured by the growth of vegetation (Figure 3, right), in particular on the terraces where the rain-water stagnates. The penetration of the roots produces, in some case, the shattering of the underlying vaults.

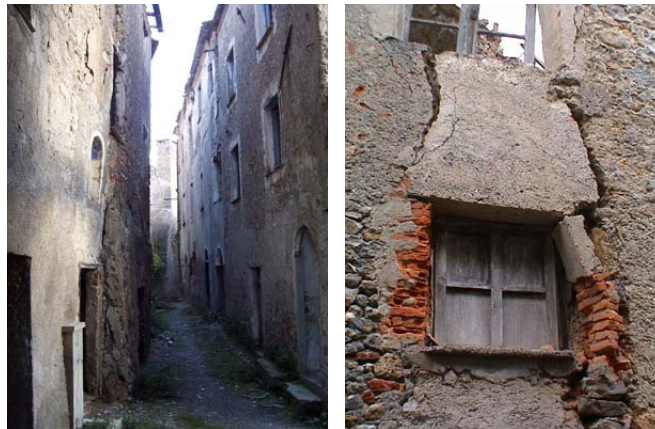
Figure 4: Inclination of the external walls (on the left); local buckling of the lintels (on the right).

The presence of thrusting structures even at the top floors, on one side, and the progressive loss of the floors, on the other side, has caused the walls to be visibly inclined (Figure 4, on the left). In some case, it is possible to find broken or unanchored tie-rods.

Finally, in the fronts of the buildings, many buckling phenomena are present. Shear cracks in the lintels, associated to a loss of squareness of the windows, can be noticed (Figure 4, on the right).

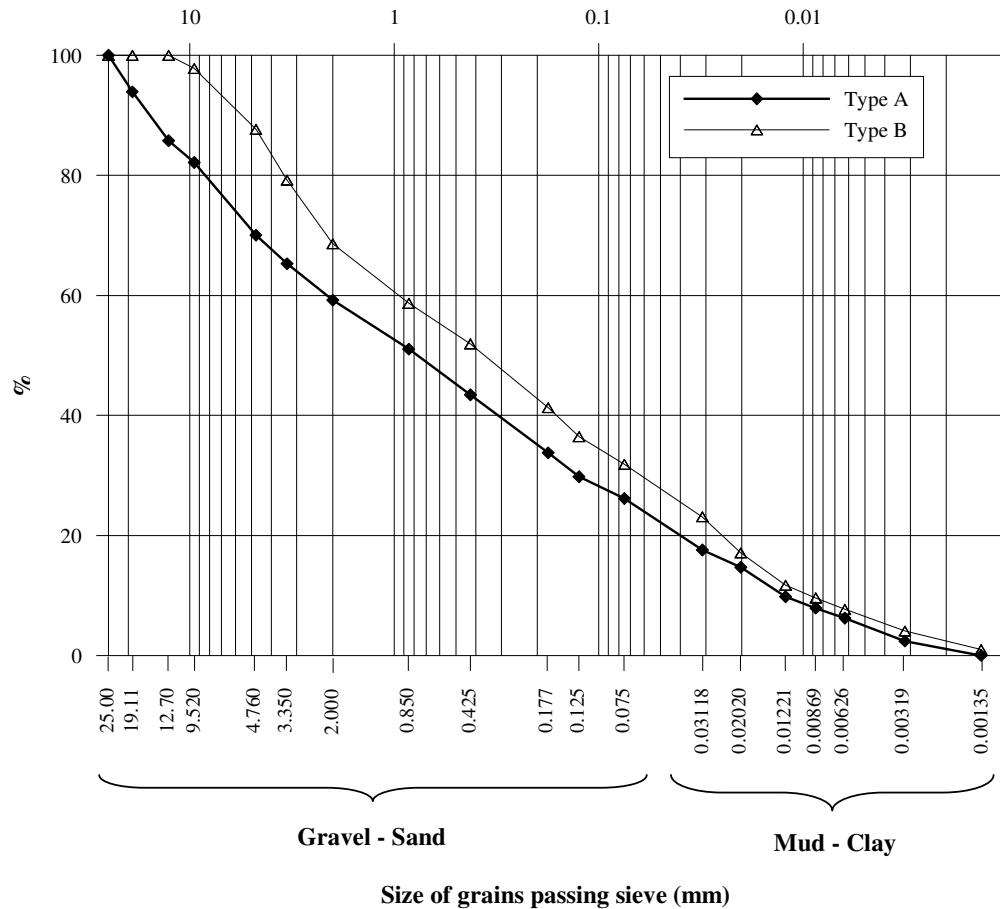
Figure 6: Grain size of earth used in this study.

From the diagram in Figure 6, which is relative to the obtained granulometry curve found by sifting, it is observable that the percentage of the quantity of grains passing through sieve ASTM 200 is similar for A and B; it is equal to 30% of the overall weight. Therefore, the evaluation of the sedimentation curve is justified. The earth A presents larger grains than B. They have a higher clay amount. The sedimentation curve underlines the fact that the earth used has a high mud amount; for this reason, in the paste of the pisè, it will be necessary to add 5% of lime, to improve the quality of the material.

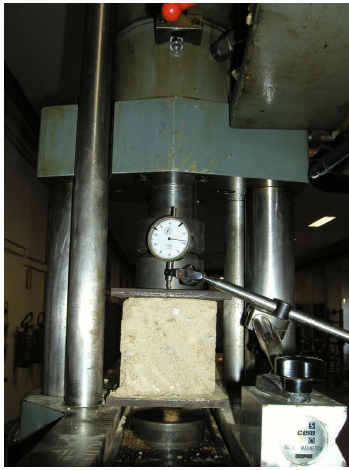
Figure 7: Test of compression (on the left); Diagram of tension – deformation of the earth A (on the right).

However, the compressive strength could have been influenced from a confinement effect, as a consequence of the compact samples. In the future, other tests will be executed on undisturbed samples with the correct slenderness (1:2). Comparing the obtained results for the earths A and B, it is observed that earth B presents better characteristics in terms of resistance. The reason could be attributed to the different water entity amount in the mixtures. In Figures 7 and 8, the diagrams about the compression and bending tests are shown respectively, in terms of tension –

deformation and loading – displacement. In particular, it is observable that the bending graphic presents a hardening phenomenon, due to the sample's compaction.

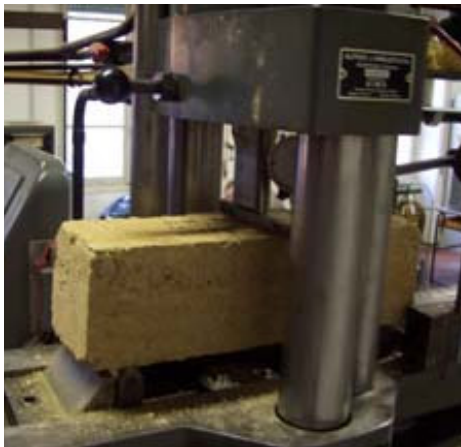
Figure 8: Bending test (on the left); Diagram loaded – displacement of the earth A (on the right).
